An Arboricultural Report on trees and Woodland at Hoyle Copse,

Stoke Gabriel,

Devon

**April 2019**

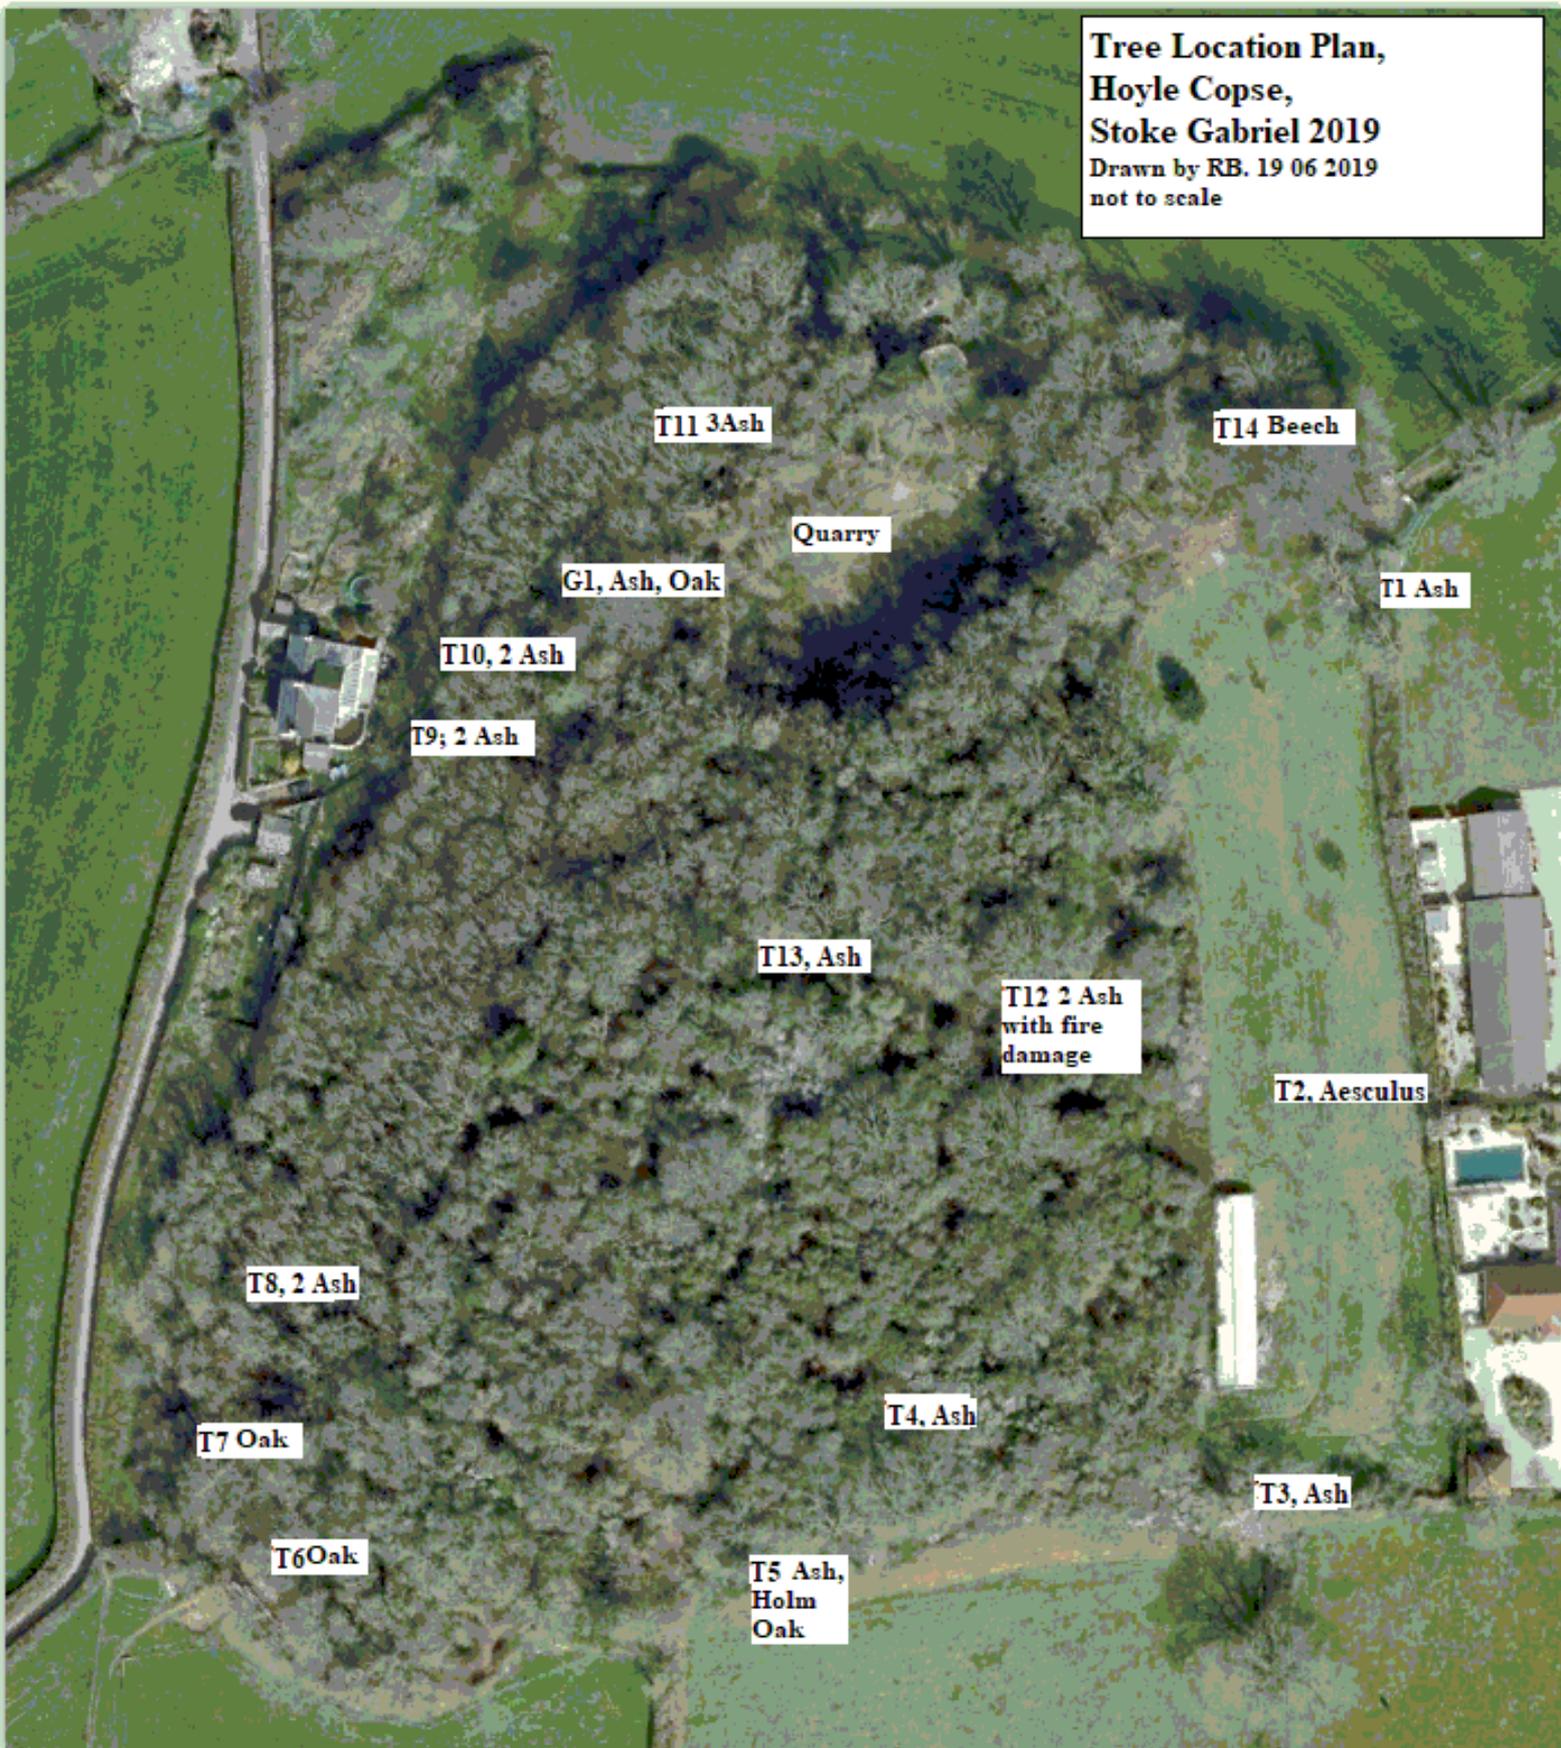
**Tree Location Plan,  
Hoyle Copse,  
Stoke Gabriel 2019**  
Drawn by RB. 19 06 2019  
not to scale

- 4.2 Please see the attached plan for the locations of the individuals and groups of trees found during the inspection to have defects or pose a potential threat to safety
